The Convict Bathhouses, Boaz and Ireland islands

BUILT HERITAGE | APRIL 2022

By Linda Abend and Margie Lloyd, Bermuda National Trust

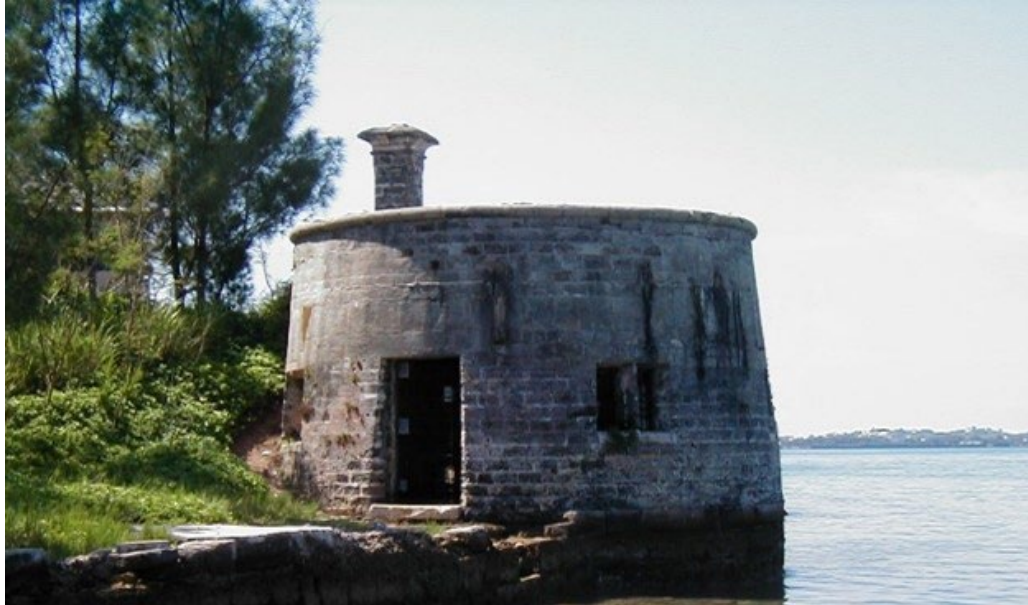
Figure 1: The most visible of the remaining bathhouses, located at the southern end of Boaz Island, was photographed several years ago when it was still in good condition. The chimney is a later addition.

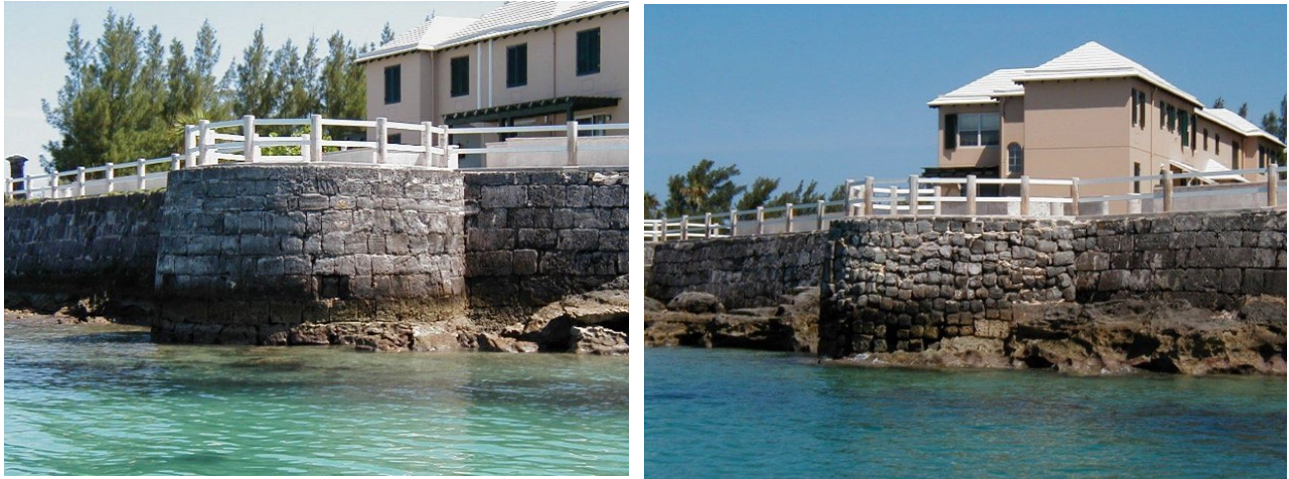
Figure 2: Bathhouses at Boaz Island look for all the world like bastions or bulwarks that are normally found at the corners of forts. Note openings that allow the sea water to enter.

At Boaz Island and at the southern end of Ireland Island are the remains of some of buildings erected by the convicts in hard Bermuda limestone for use as bathing houses. They appear as small towers, in effect cells open to the sky, but walled in so as to form a room on the water's edge. They were designed to have sea water flow into them through holes at such a height that there was always water for bathing. The buildings had a single entry consisting of steps down into the water, and convicts were therefore confined during their ablutions. This prevented escapes that might occur if the men were allowed to bath directly in the sea. While most were circular structures, square shaped bathhouses were also built.

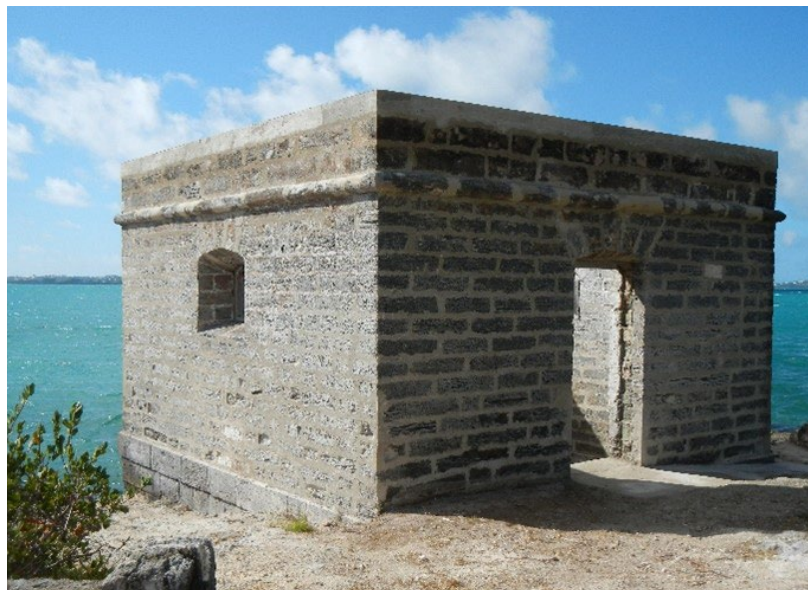
Figure 3: A happy result for the bathhouse on Hospital Island which was restored in 2014 through a partnership between the National Museum, WEDCO and Correia Construction.

For more information on the convicts employed at the Dockyard, the following books are highly recommended: *Forty Years of Convict Labour* by C F E Hollis Hallett and *The Andrew and the Onions* by Ian Stranack. Also consulted was *Heritage Matters* Vol. 10 by Dr Edward Harris and a *Bermuda Sun* article of 30 July 2014 on the restoration initiative on the bridge and bathhouse at Hospital Island.

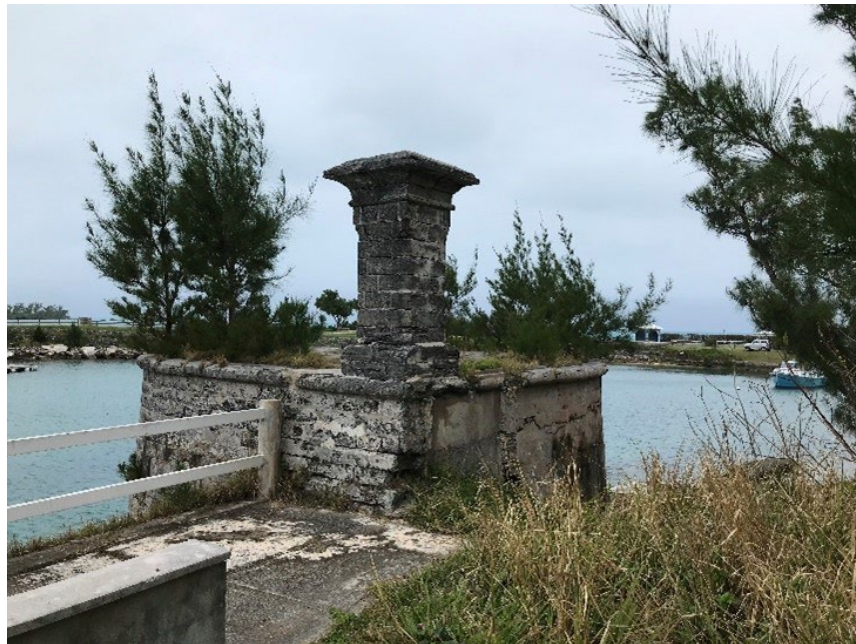
Figure 4: The bathhouse turned cookhouse is in danger of being taken over by the fast-growing casuarina.

In 1848 a prison was built at Boaz Island and the circular ones were built nearby. No further convicts were sent to Bermuda after 1861 and the last of them returned to England in 1863. At some point most of the bathhouses were roofed with one having a chimney added.
